MATERIAL WICKING

WE HAVE AIR COMING OUT OF A SEAM AND CANNOT FIX IT. WHAT DO WE DO?

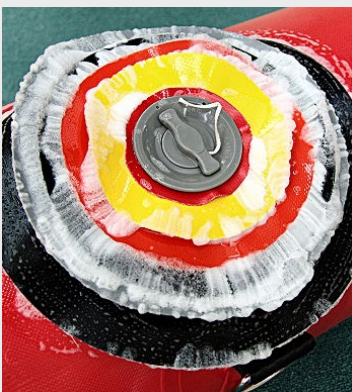
Most hypalon materials – at least those with lightweight reinforcement – had very low wicking rates. What we have

done in the photo at left is fit 6 different polyurethane material samples under the valve, removed the O-ring seal, and inflated to standard operating pressure. This allows air to travel up the valve nut threads and access the valve hole at centre of each of the sample discs. The detergent solution

shows the air coming from the disc edges. Some samples wick more than others but in fact they all wick.

This arrangement has exactly the same effect as when you patch a puncture on the outside. It allows air to migrate through the scrim. Air will escape through nearby panel edges (at the seams). These are not seam leaks and cannot be fixed by patching. Air will also escape from every little scratch in the outside coating (normal wear-and-tear).

Repair punctures always so that the integrity of the inside coating is restored.

On a small puncture this might mean pinching/puckering the material between your fingers so you can give the material edges a few coats of glue (allow to dry 30 minutes between coats). The first glue coat will soak into the scrim and so might the second, and with a third coat you should have a seal. Then a small patch on the outside will be fine.

Patch on the inside any larger puncture (say 25mm or more). This is not especially difficult to do and you don't have to be so careful about unsightly glue lines. Masking tape applied either side of the repair will keep the outside looking good too. If you do neat work the finished result will be all but invisible.
